# Flight Safety News Letter

# Case Study

## Loss of LH outer wheel assembly (ARTICLE BY M/s ATR)

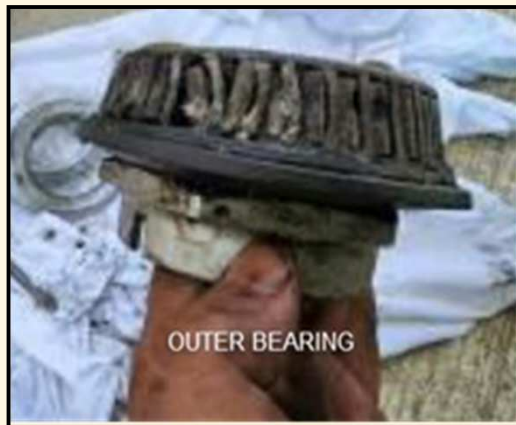
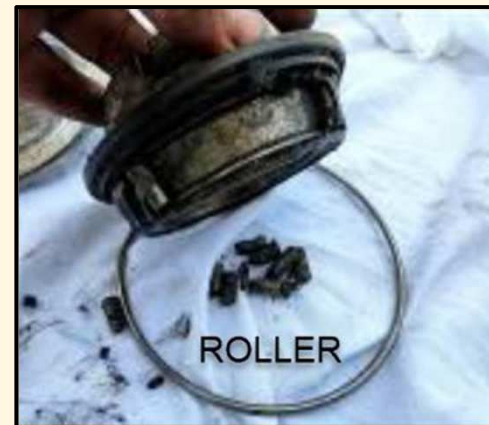
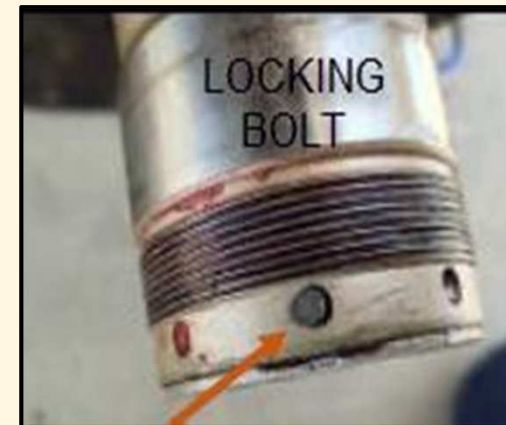
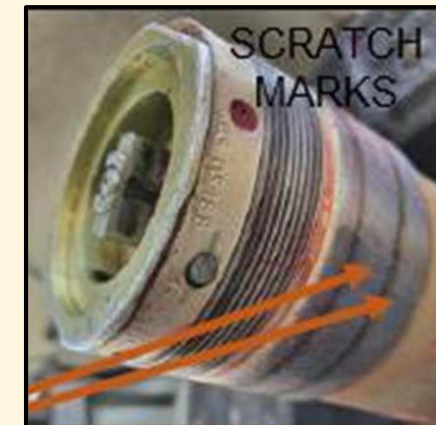
Damage was observed on:

- Hub Locking bolt broken into 2 pieces.
- Roller Bearing.
- Left wheel axle (Scratch marks were found on the shinning portion)

(Detachment of the outer wheel assembly from the wheel axle)

The aircraft was kept under storage with limited preventive maintenance, from September 2016 to May 2018. The wheel assembly was removed from aircraft as serviceable condition and was kept in store from April 2018 until June 2020. No documentation was found about the wheel bearing greasing during this period. This wheel was installed in the aircraft on June 2020 and was removed from the aircraft as unserviceable on August 2020 and was returned to store. The store could not produce any document as to how this unserviceable wheel was made serviceable. The aircraft maintenance organization could not show any document asked by the investigation board as to how this wheel was made serviceable, when it was installed in the aircraft and in which date.

Improper or no maintenance was carried out for the lubrication of the main landing gear wheel bearing, axle etc. during the long/ short term preservation of the aircraft and when the wheel assembly was kept in the store for about 2 years. This improper/ no maintenance contributed to the formation of corrosion in static condition and ultimately contributed to this serious incident.

- i. One time inspection is to be carried out to check the condition, especially the presence of corrosion, crack or any other abnormalities to all bearings ... This is applicable to all operators of Bangladesh using ATR aircraft in their fleets.
- ii. The aircraft operating at Cox's Bazar are more susceptible to corrosion due to salinity. As such a preventive corrosion control program may be introduced in the Aircraft Maintenance Programme (AMP),...This is applicable to all aircraft operating in Cox's bazar.

- i. Effective supervision and monitoring for field level activities may be introduced by the operator in order to ensure that company policies and procedures are strictly adhered to minimize the gap between field and supervisory level and thereby ensuring safe operation of flight.
- ii. Perform the lubrication of wheel bearing in accordance with instruction of CMM. To avoid the ambiguity and for more clarity the operator should introduce a local task card on wheel bearing greasing following the procedures in the CMM. This is applicable both for the line maintenance and store.
