FLIGHT SAFETY NEWS LETTER

CFIT – Controlled Flight Into Terrain

Aircraft : ATR 72-600

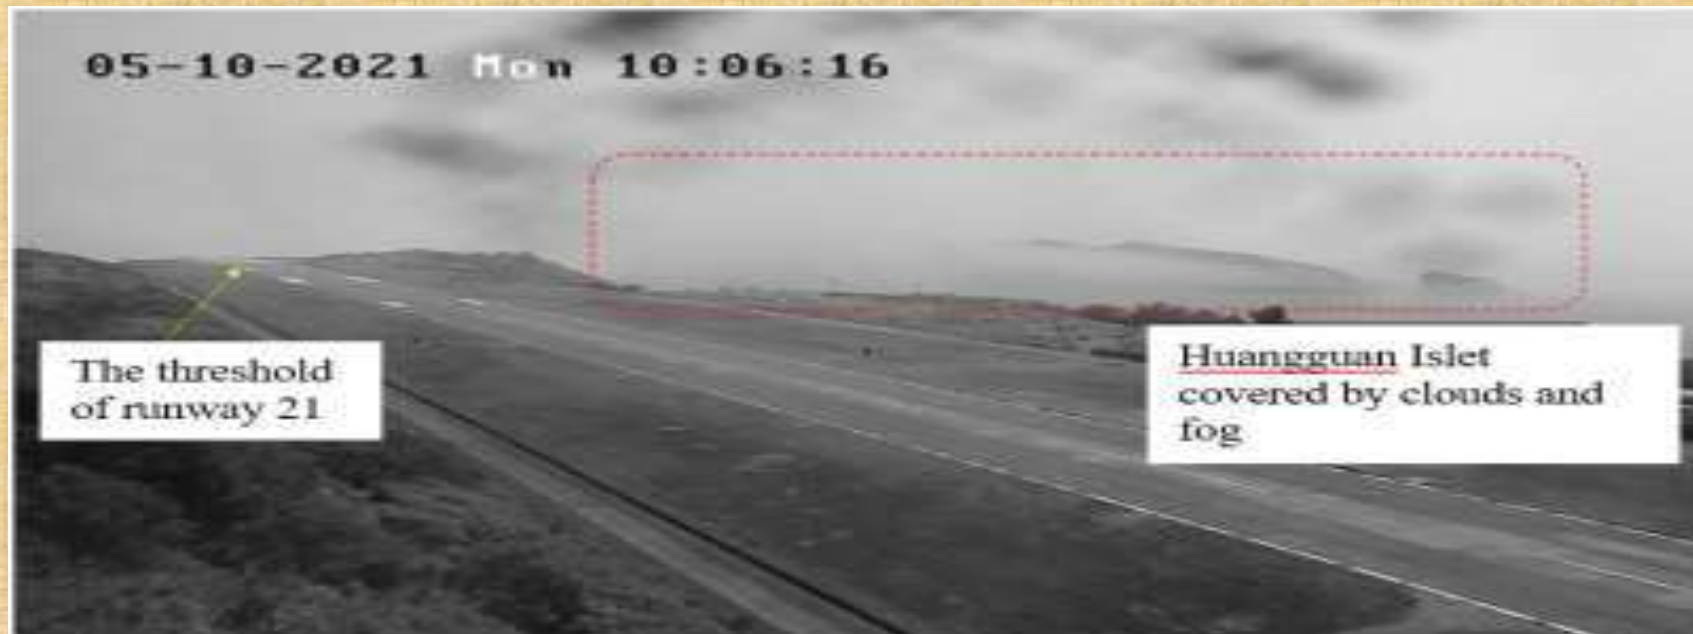
About 30 minutes before and after the aircraft touched down, there were low clouds (the cloud base was lower than the airport height). Fog on the sea to the east and north of the airport, moving to the north could be seen about 1.5 km northeast of the tower platform on Huangguan Islet.

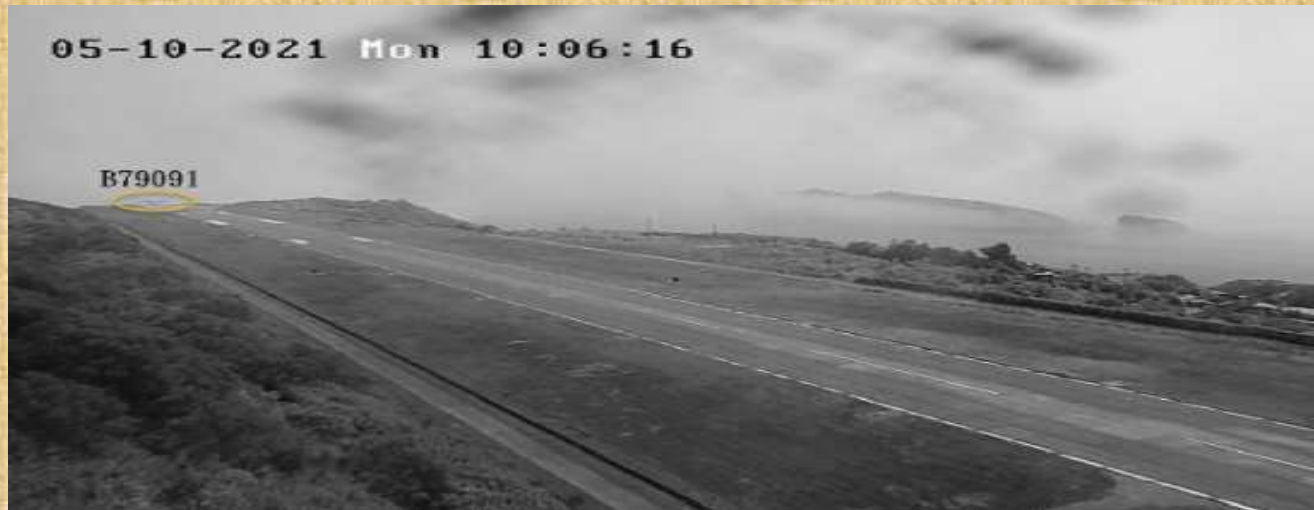
The scheduled flight B7-9091 performed a non-precision approach to runway 21 of Nangan Airport, the pre-threshold area was obscured by low clouds or marine fog. During the final approach, the pilot flying used the autopilot lateral navigation (LNAV) mode and vertical speed (VS) mode for the approach.

At 1006 LT, the aircraft penetrated the low cloud/fog not far from the threshold of runway 21 (*orange circle on the picture below*).

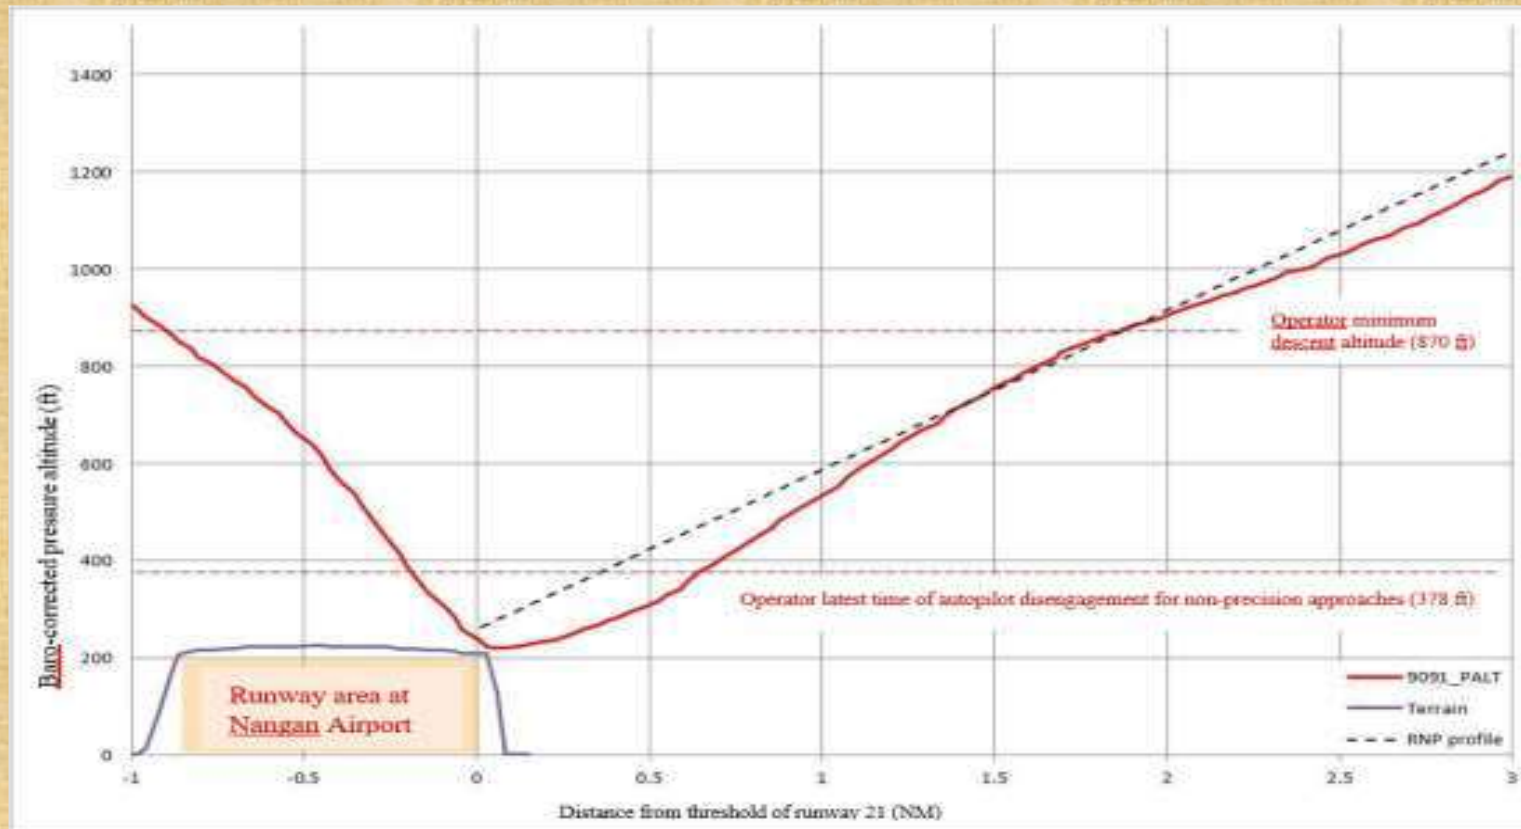
The pilot flying lost situational awareness of the aircraft position and did not realize that the aircraft altitude was very close to the runway threshold elevation. When the aircraft entered low clouds and was unable to maintain visual contact with the runway below the MDA, the pilot flying did not follow the procedure of immediate execution of a go-around but continued using the autopilot for the approach. The pilot monitoring did not remind the pilot flying to execute or call for a go-around.

When the pilot flying decided to perform a go-around, the aircraft had reached an altitude of 229 ft, 11 ft above the runway threshold elevation (THR RWY213 Elev: 218 ft). Because the altitude was too low, before the aircraft could establish an effective positive rate of climb, the aircraft's main wheels and tail skid collided with the top outer edge of the pre-threshold area of runway 21, causing substantial damage to the aircraft.

1. Strengthen the safety monitoring mechanism, identify and prevent the flight crew from deviating from the standard operating procedures (SOPs), and require the pilot monitoring to achieve the functions of team cooperation, reminder and correction, to reduce the risk of flight operations.
2. Review and strengthen Controlled Flight Into Terrain (CFIT) risk control and preventive measures based on organizational characteristics, operational patterns, and safety data analysis results, including: identification and monitoring of relevant hazards, establishment of safety performance indicators and goals, and enhancement of risk awareness among the flight crew, etc. to prevent the recurrence of similar occurrence.

1. Supervise *the operator* to strengthen the safety monitoring mechanism to:
 - Identify and prevent the flight crew from deviating from the standard operating procedures (SOPs), and require the pilot monitoring to achieve the functions of team cooperation, reminder and correction.
 - Review and strengthen Controlled Flight Into Terrain (CFIT) risk control and preventive measures, including: identification and monitoring of relevant hazards, establishment of safety performance indicators and goals, and enhancement of risk awareness among the flight crew, etc. to reduce the risk of flight operations

2. Evaluate the installation of relevant auxiliary equipment at Nangan Airport, or provide meteorological observation guidance to assist meteorologists in observing and reporting marine fog or low clouds on the outer side of the runway threshold.
3. Review Nangan Airport's runway end safety area and declared runway distances in accordance with the Civil Aerodrome Design and Operation Standards. In addition, examine whether any other affiliated airport has a similar configuration.

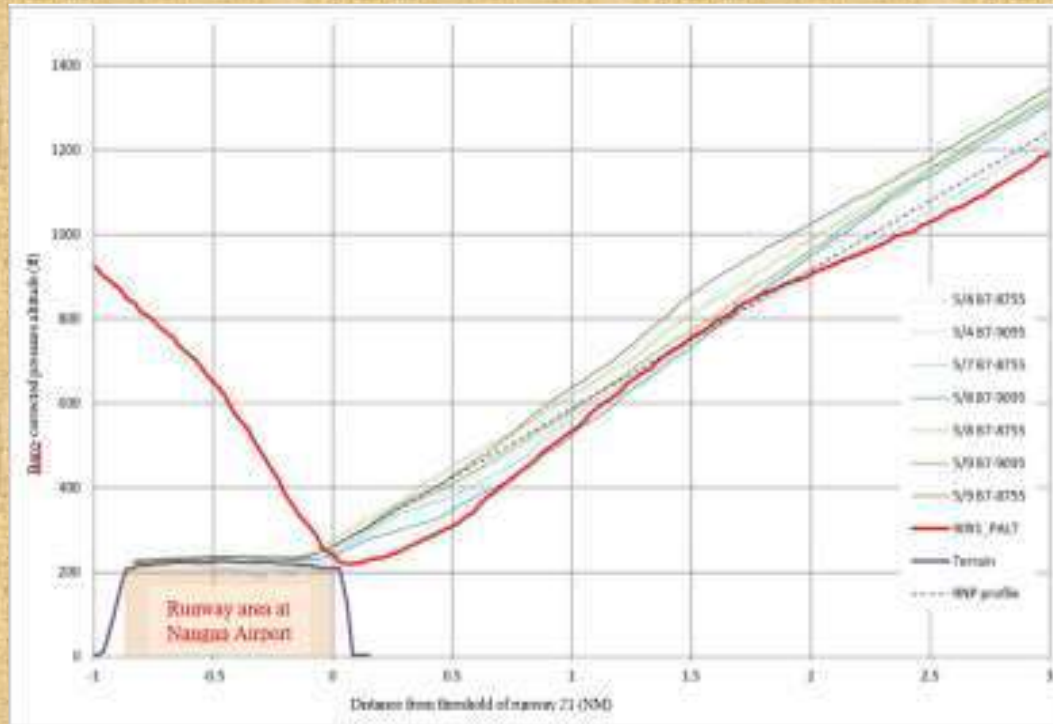
Extract from the final report. The red line is the flight B7-9091. The dashed line is the RNP profile. The other colors are different flight

The safety margins are reduced if:

- The crew fly in short final below the flight path (as duck & dive).
- The crew continue the approach with loss of visibility or unstabilized approach.

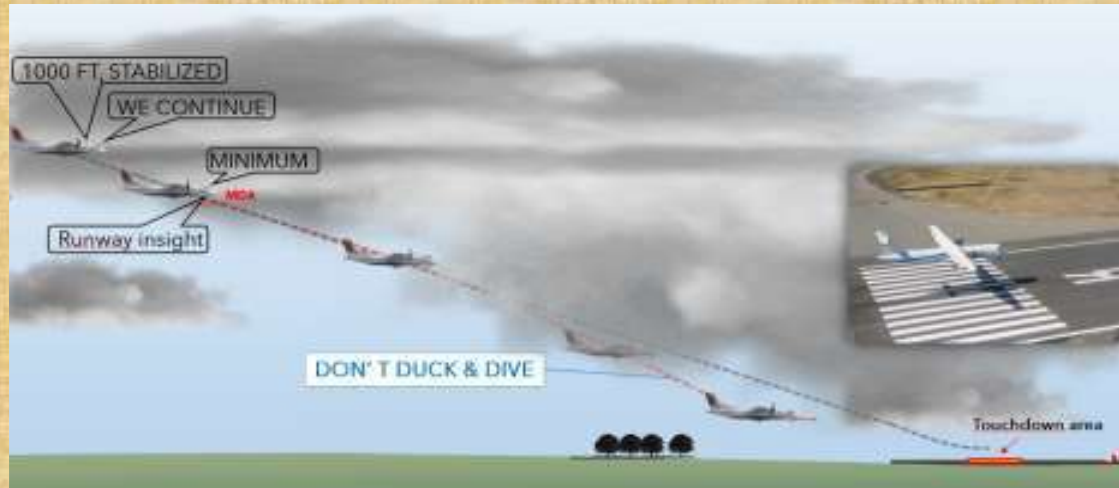
***“Do not
Duck & Dive.”***

- Respect the **STABILIZATION CRITERIA.**

Stabilized approach equals stabilized all the way to touchdown.

- BE prepared for a GO-AROUND
 - Review the main task sharing (PM & PF) in a short briefing.
 - Identify the Threat(s) on this specific approach. (Complex trajectory, congested airport, ...)
 - Identify the Threat(s) that could destabilize the approach (low visibility, wind, ATC runway change, ...).
